Bridgetown Waste Facility Expansion Project

Stage 1 – Leachate Pond

Project Description

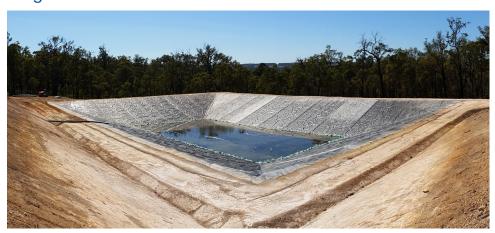
Works comprised removing and stockpiling the initial 400mm of the existing ground and stockpiling as unsuitable material. The 10,000m³ of clay cut to fill material was then conditioned, placed and compacted to build the dam. The dam was lined with 5,000m² of geosynthetic clay liner and covered with HDPE liner.

In the overflow pond, the floor was cut and trimmed, and then had $8,000\text{m}^2$ of geofabric placed on the floor. This was covered with 300mm of blue metal ballast with 180m of a 160mm HDPE leachate pipe within the ballast, which was welded together and connected to the main dam. The geofabric was then wrapped over the ballast to form a sealed leachate.
